# HS TYPE CARBURETTOR - INSPECTION

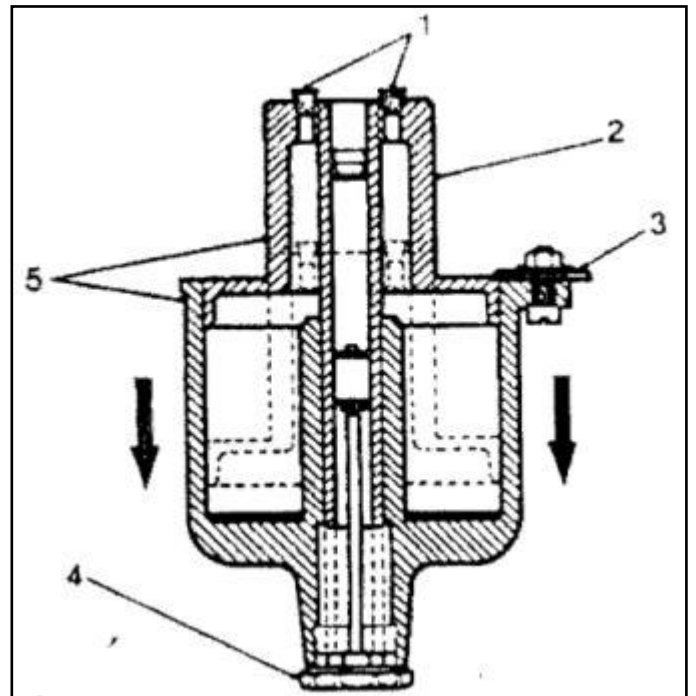
- (a) Temporarily plug the piston transfer holes (1).
- (b) Fit the piston into the chamber without its spring (2).
- (c) Fit a nut and screw, with a large flat washer under the nut, into one of the suction chamber fixing holes, positioning the washer so that it overlaps chamber bore (3).
- (d) Fit the damper and washer, if fitted (4).
- (e) Check that the piston is fully home in the chamber, invert the assembly to allow the chamber to fall away until the piston contacts the washer (5).
- (f) Check the time taken for the chamber to fall the full extent of the piston travel. For carburettors 38.0 mm (1.5 in) to 47.6 mm (1 7/8 in) bore, the time taken should be 5 to 7 seconds.
- (g) If the times are exceeded check the piston and chamber for presence of oil, foreign matter and damage. If after re-checking the time is still not within these limits, renew the suction chamber assembly.

The following timing check applies only to standard suction chambers and need only be carried out if the cause of the carburettor malfunction which necessitated the dismantling has not been located.
